NAVAL SURFACE WARFARE CENTER

PMP LESSONS LEARNED

GLENN BENNINGER
ADVISORY COORDINATOR
30 AUGUST 2011

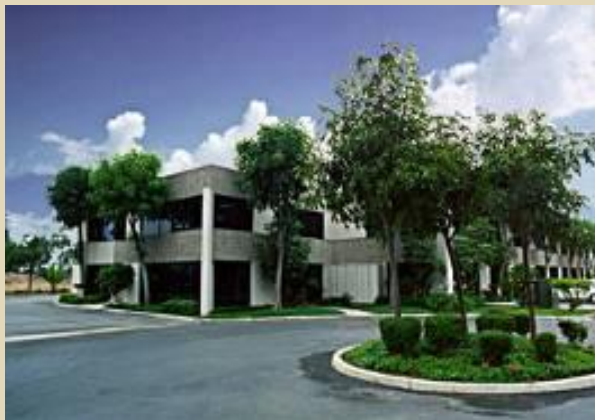
Website photo

Both distributors sell (sold) to defense contractors. Both advertise availability to thousands of components. Both are residential businesses.

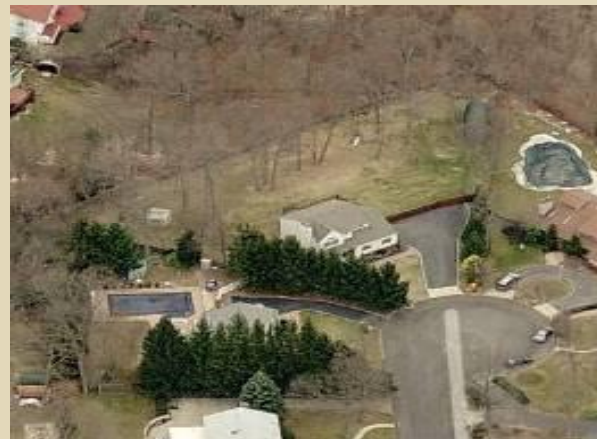
Actual “facility”

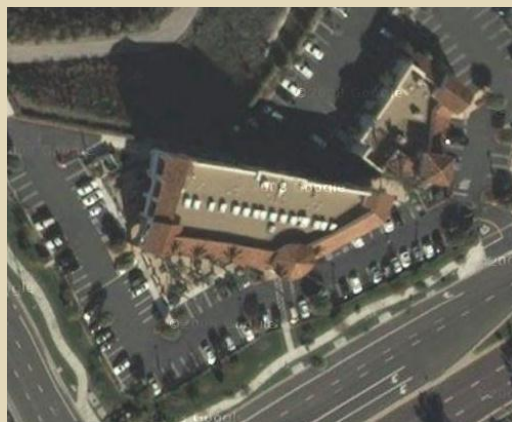
Website address

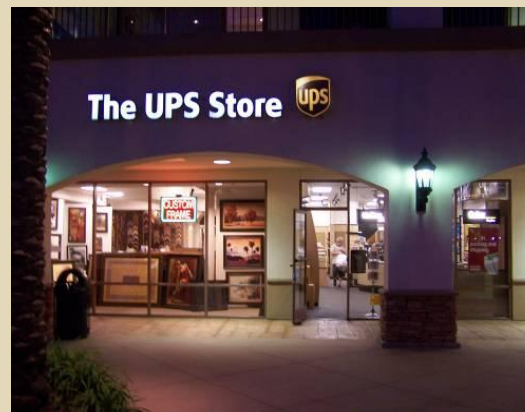
Actual “facility”
